Vehicle Proximity Alert System for Highway-Railroad Grade Crossings-Prototype Research

Safety of Highway-Railroad Grade Crossings

DOT/FRA/ORD-01/01

Final Report
April 2001

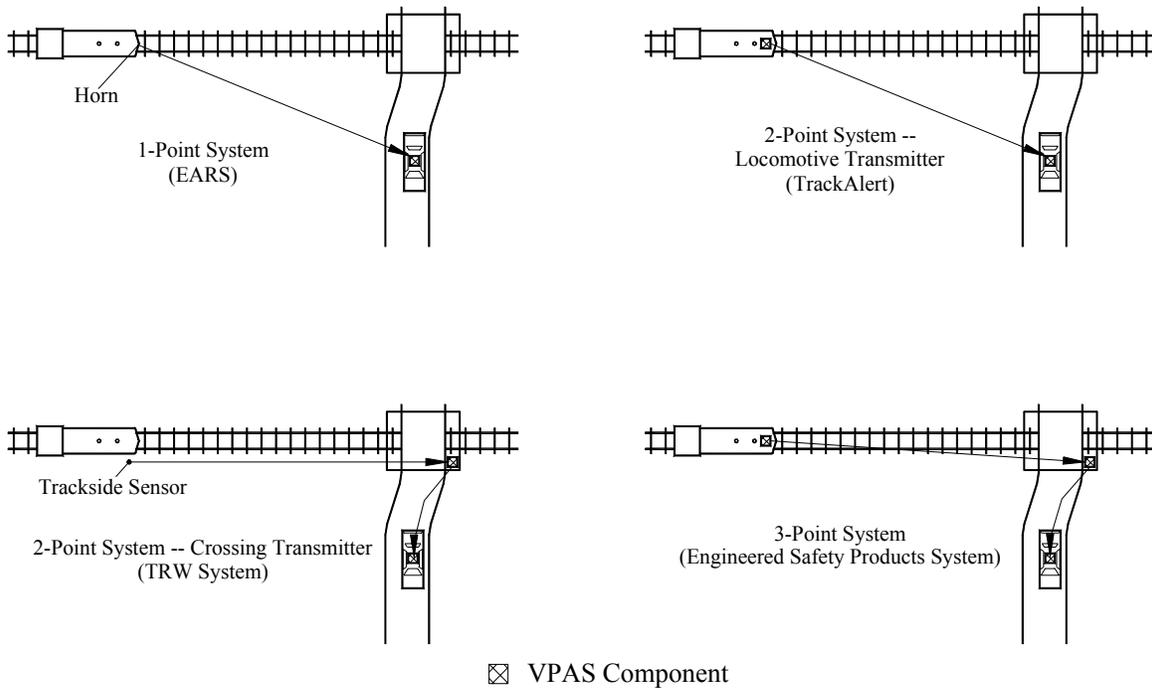
Figure 3-1. VPAS Technologies

- (1) A one-point system proposed by Custom Automated Plastic System Inc.—the Early Alert Response System (EARS).

- (2) A two-point system with the transmitter in the locomotive proposed by RF Solutions—TrakAlert.
- (3) A two-point system with the transmitter at trackside proposed by TRW.
- (4) A three-point system proposed by SmartStops.

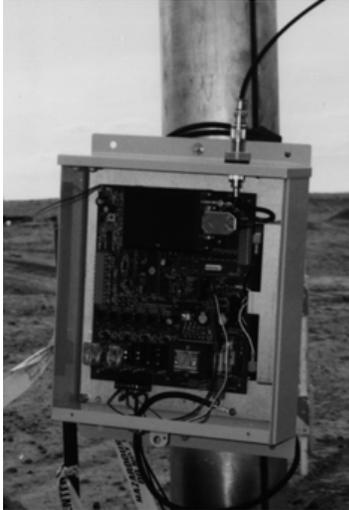
Figure 3-5. SmartStops Crossing Transceiver

As shown in [Figure 3-2](#), this system consisted of a transceiver mounted in a locomotive, another transceiver mounted on a pole at a crossing, and a receiver installed in a motor vehicle. The transceivers use an RF signal, operating at 151.7 MHz, and dual-tone multiple frequency (DTMF) codes. An unregulated 12-VDC battery powers the receiver. The transceiver installed in the locomotive is shown in [Figure 3-3](#), the mounted antenna for the locomotive transceiver is shown in [Figure 3-4](#), the transceiver mounted at the crossing is shown in [Figure 3-5](#), the mounted antenna for the crossing transceiver is shown in [Figure 3-6](#), the receiver is shown in [Figure 3-7](#).

The locomotive transceiver transmits its signal at a constant rate when the locomotive is operating. As the locomotive approaches a crossing, the pole-mounted transceiver decodes the DTMF signal from the locomotive. If the appropriate code is received, the pole-mounted transceiver transmits another signal, which is coded differently from the locomotive signal. The signal from the pole-mounted transceiver is collected by any motor vehicle with a receiver within range of the crossing, and an alarm is sounded and displayed in the vehicle. That signal is also collected by the locomotive transceiver, which displays a message to the locomotive operator that the locomotive signal has been received at the crossing and a second signal has been transmitted.

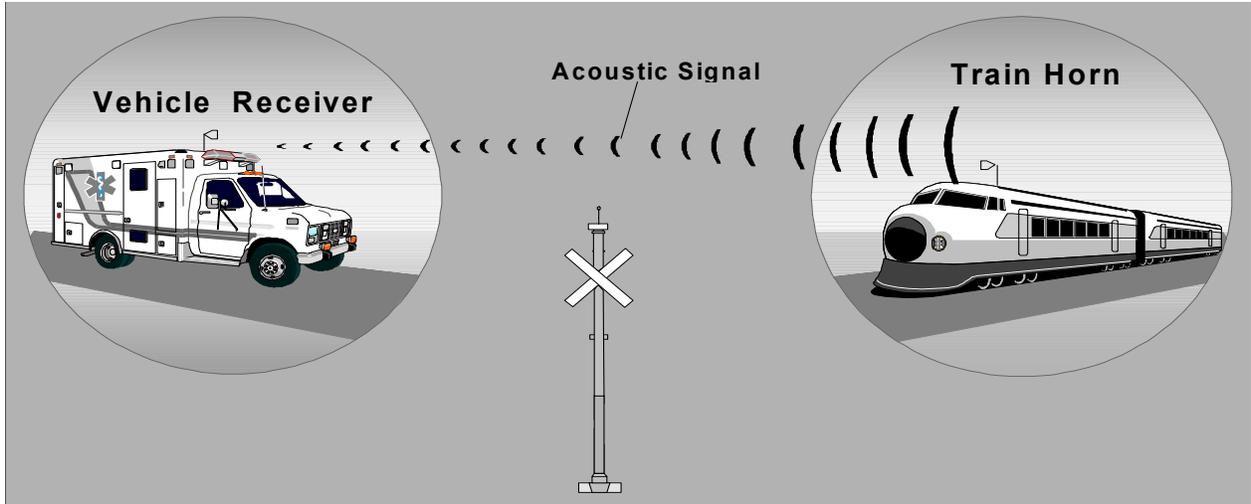
Figure 3-8. EARS Signal Reception

EARS is an acoustic-detection system that selectively responds to the audio frequency spectrum of locomotive horns as shown in Figure 3-8. The VPAS component consists of a microphone transducer mounted outside the vehicle (shown in Figure 3-9) and a digital signal processor (shown in Figure 3-10) mounted inside the vehicle. The processor uses an algorithm to analyze the frequency content of the audio signals received by the microphone transducer. When the appropriate frequencies are recognized, both a visual and an audio warning signal are generated in the vehicle. The primary power source for the system is the unregulated 12 VDC vehicle battery.

EARS was originally designed to visually inform hearing-impaired motorists of the proximity of an emergency vehicle. The microphone receives an audible frequency signal transmitted by the siren, the signal is analyzed to determine the type of siren, and a visual alarm and an audible alarm are activated. The system was adjusted to allow the detection of locomotive horns.

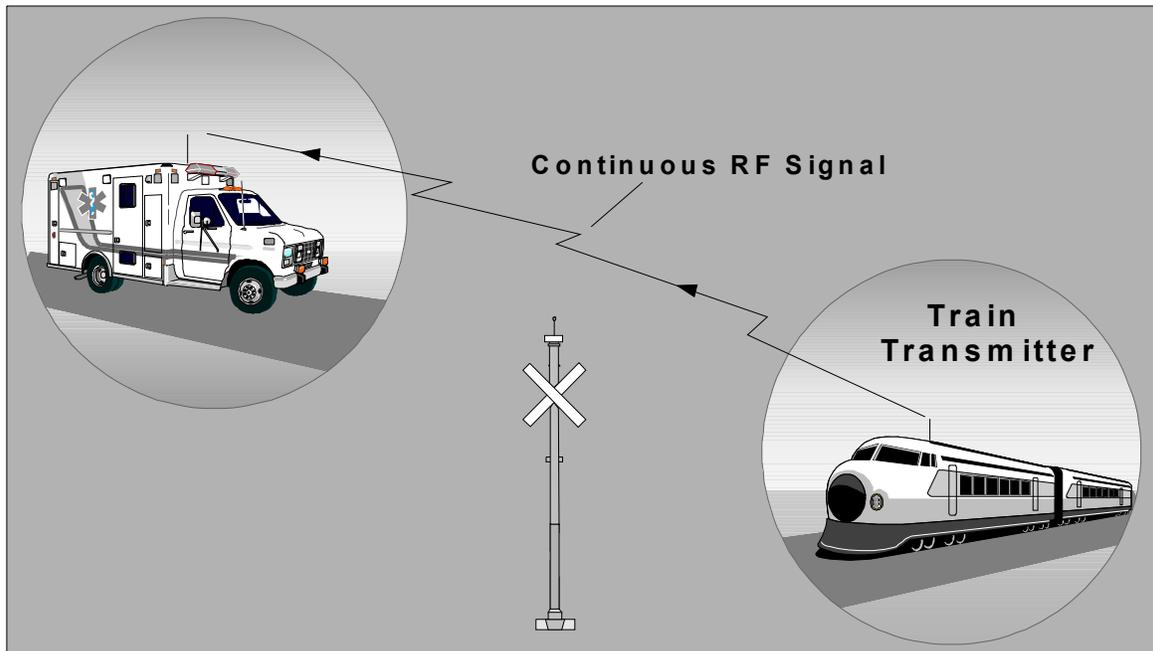
Figure 3-11. DVSS System Signal Transmission

Because the test locomotives at TTC were not equipped with FREDs, DVSS supplied the front-end transceiver from a FRED used in commercial freight service and installed it in the test locomotive. The FRED supplied by DVSS, which was used only for transmitting during testing, is similar to ones used on most Class 1 railroads. FREDs operate at 452 MHz to 458 MHz. A signal transmission diagram for the DVSS system appears in Figure 3-11.

When a warning signal is received in the vehicle, a visual alarm and an audible alarm are activated. Because of the continuous transmission by the FRED, reception of a warning signal by the VPAS receiver is not confined to the vicinity of a crossing where a train is approaching.

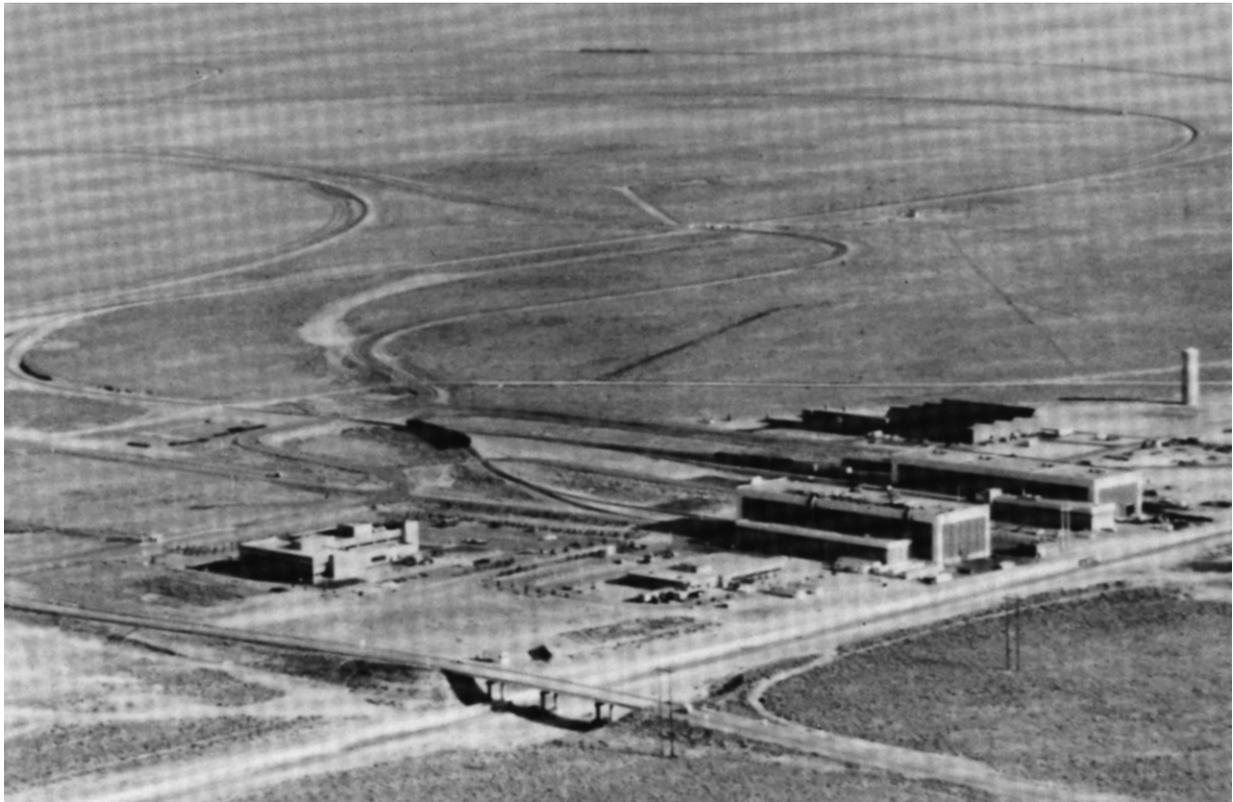
Figure 4-1. TTC Test Site Aerial Photograph

The TTC test site (shown in Figure 4-1) is located in a generally flat, semi-arid, high-altitude open area with little vegetation in Pueblo, Colorado. This area is subject to heavy sustained gusting winds and sudden shifts in wind speed and direction. It is also subject to wide fluctuations in temperature between daytime and nighttime. Since the testing was regularly conducted during pre-dawn hours as well as mid-day, the temperature swings during testing were

a factor. Since all of the tests were also conducted during winter or late fall, the test temperatures ranged from subfreezing to 70s° F (25° C), and the precipitation consisted of snow, rain, and a mixture of both. Although weather was not a formal test variable in any of the test phases, it was always considered to be a factor that could affect system performance and was monitored regularly, as discussed in Section 4.2.

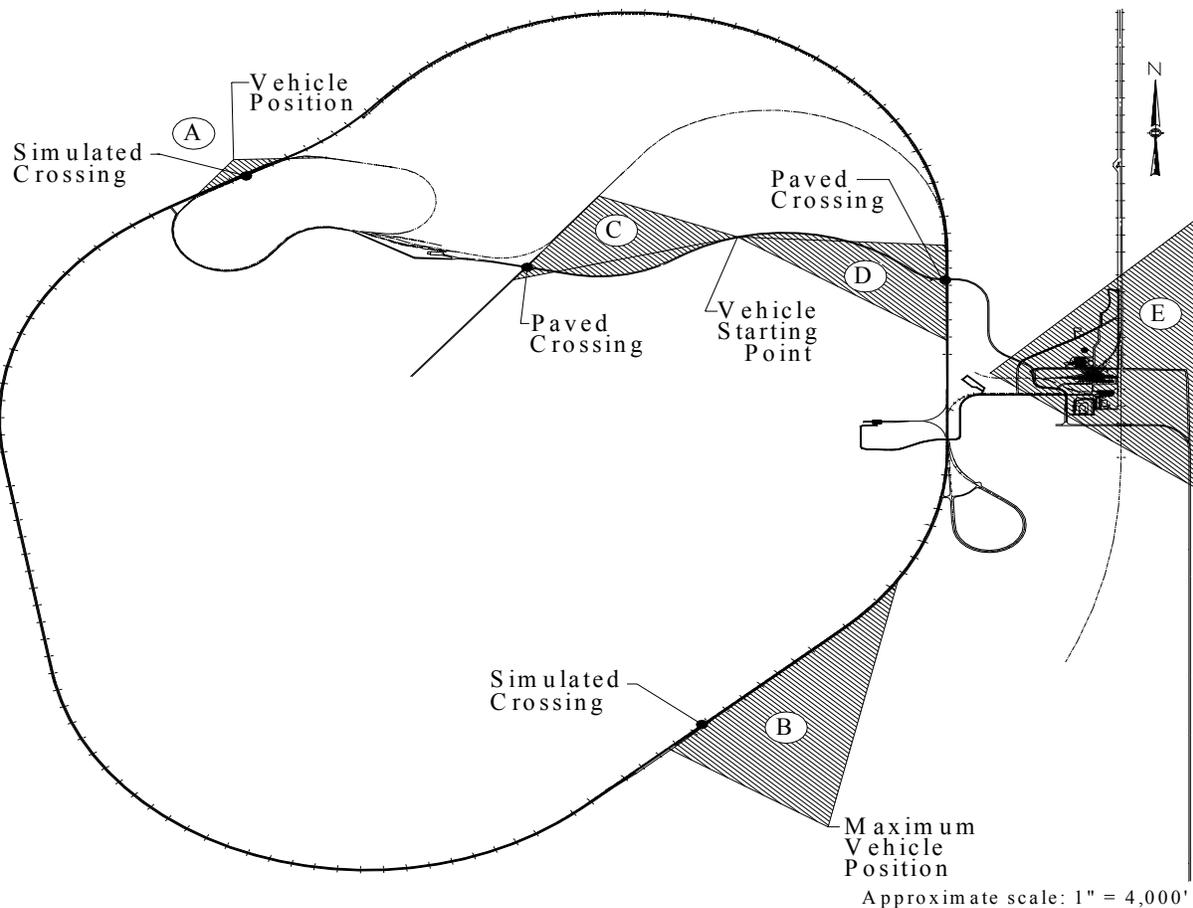
Figure 4-2. Location of Test Zones at TTC

A map of the TTC test site and the VPAS test zones appears in Figure 4-2. The only obstructions to wind and signal transmissions at the test site are the buildings and other structures in the TTC core area in test Zone E. Phase 1 and 2 testing was conducted in Zone A. Phase 3 was conducted in two segments: one in Zone B and the other in Zones C and D. Phase 4 was also conducted in two segments: one in Zone B and the other in Zone E.

*The directions of train travel (clockwise and counterclockwise) noted in this table refer to the directions on the loop that contains the Zone A track segment (see Figure 4-2). The CW direction is roughly southwest to northeast, and the CCW direction is roughly northeast to southwest.

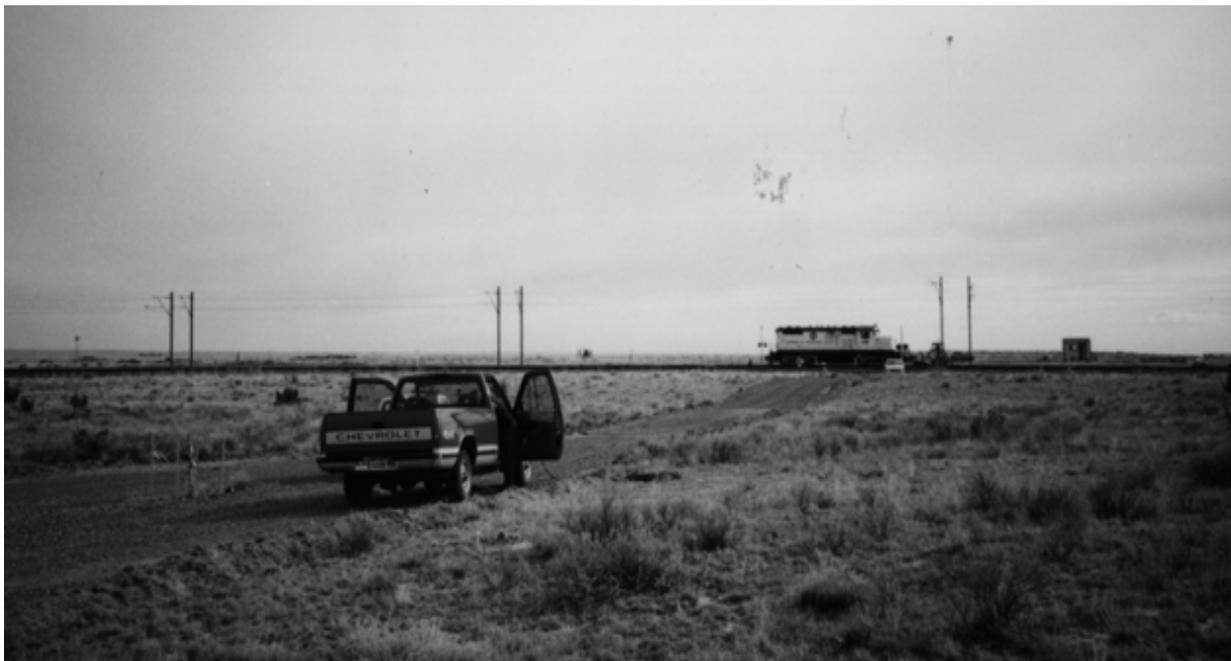
Figure 4-5. Zone A Test Area

Phase 1 testing was performed with the locomotive moving in Zone A at speeds up to 40 mph (64 km/h) while the vehicle remained stationary on a straight roadway approximately 500 ft. (150 m) from and perpendicular to a simulated crossing; see Figures 4-5 and 4-6. The locomotive's test zone boundary was 1,760 ft. (528 m) on both sides of the crossing. An ALD was installed at each end of the zone and at midpoint of the crossing, activating the locomotive transmitter or horn when the locomotive entered the zone and shutting it off when the locomotive exited.

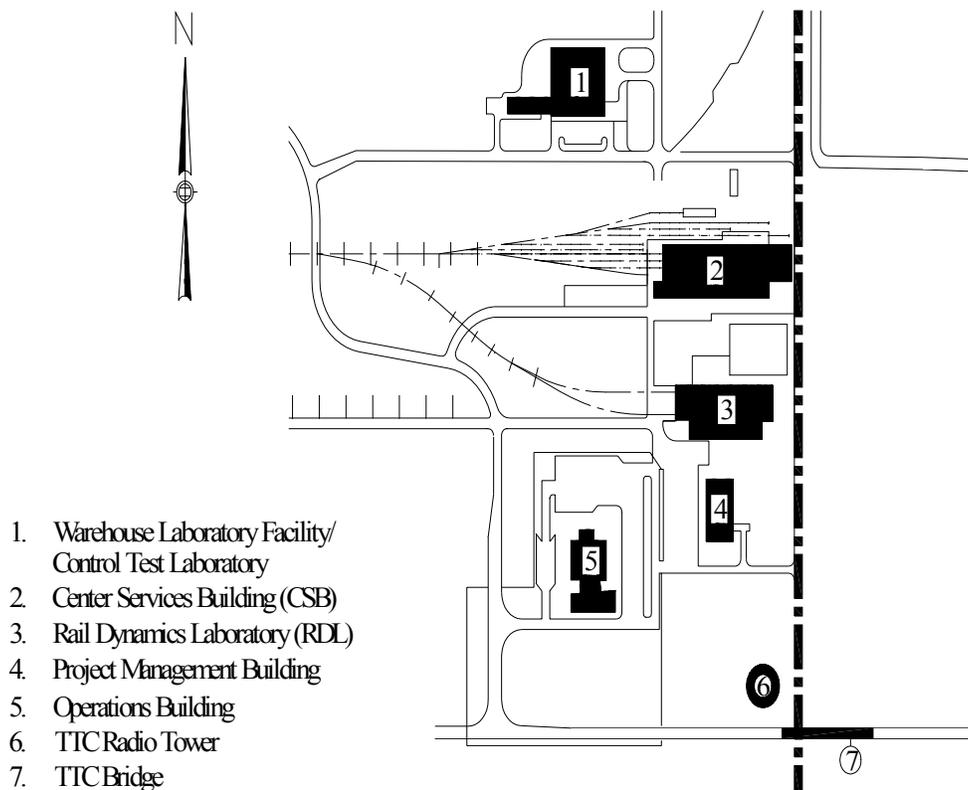
Figure 4-10. Zone E Test Area

This segment was conducted in Zone E (see Figure 4-10). The buildings and vehicles in the core area, the TTC radio transmission tower, and the TTC bridge were used to cause shading and reflection of the transmitted signal. (The buildings are shown in Figure 4-1; the radio tower and the bridge are shown in Figure 4-11.) The vehicle was parked at different locations among the buildings and at different distances from the simulated crossing, and the locomotive approached at different speeds (from the north during some runs and from the south during others) and at times was stationary under or near the radio tower or the bridge. The number of test runs performed, the train speed and travel direction, and the locomotive and vehicle locations varied from system to system to accommodate differences in system designs. During SmartStops system testing, the vehicle was mobile through the complex of buildings for two runs, and the crossing antenna was moved to different locations.

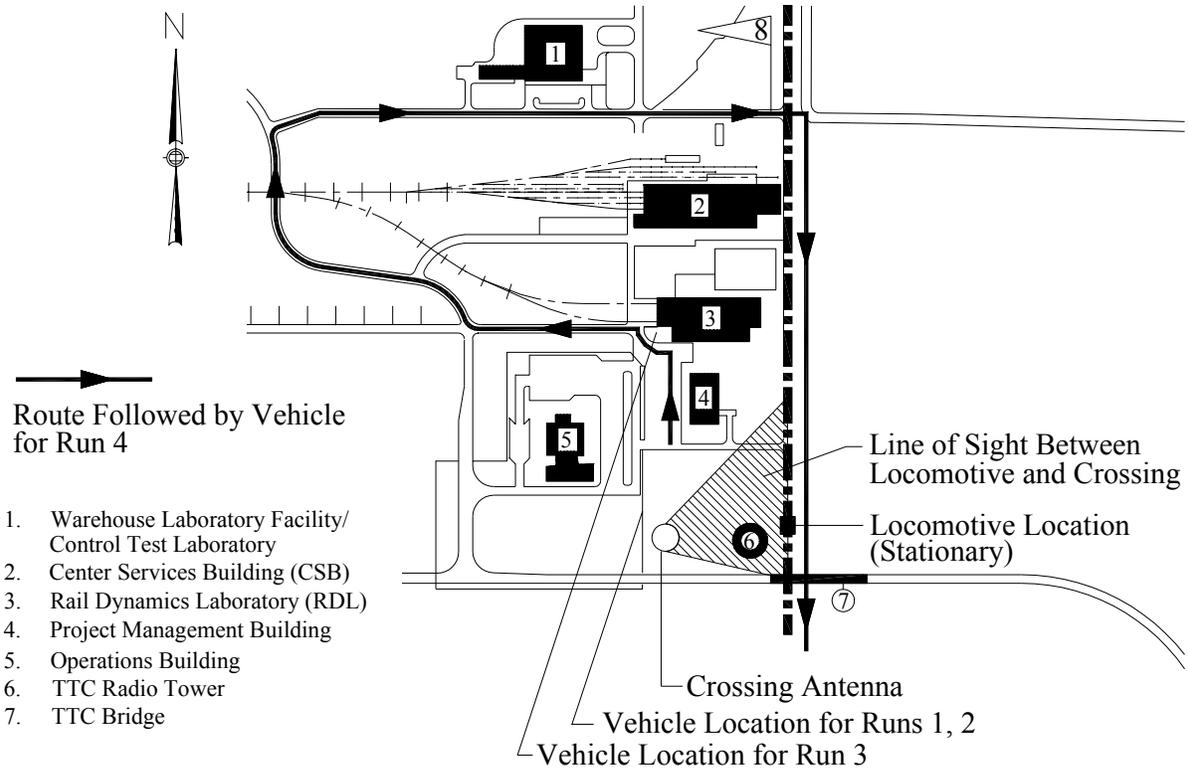
Figure 5-1. SmartStops System RFI Testing in Zone E

The first eight of the nine signal masking trials were performed with the locomotive traveling at 30 mph (48 km/h) with the vehicle parked in different locations. During the last trial, the locomotive was stationary (within direct line of sight of the antenna) while the vehicle traveled around the core area. The crossing antenna remained approximately 550 ft. (165 m) west of the test track opposite the tower during the first four runs. Following the fourth trial, the crossing antenna was moved between the Center Services Building (CSB) and the Rail Dynamics

Laboratory (RDL) approximately 500 ft. (150 m) from the test track. Figure 5-2 shows locomotive, crossing, and vehicle locations for the signal masking trials.

There were minor signal disruptions at the vehicle receiver during each of the first eight signal masking trials. There were intermittent signals and momentary loss of reception during the last run as the vehicle traveled between Markers 8 and 14; see Figure 5-2. Table 5-7 summarizes the test configuration and the signal reception at the vehicle for each masking test.

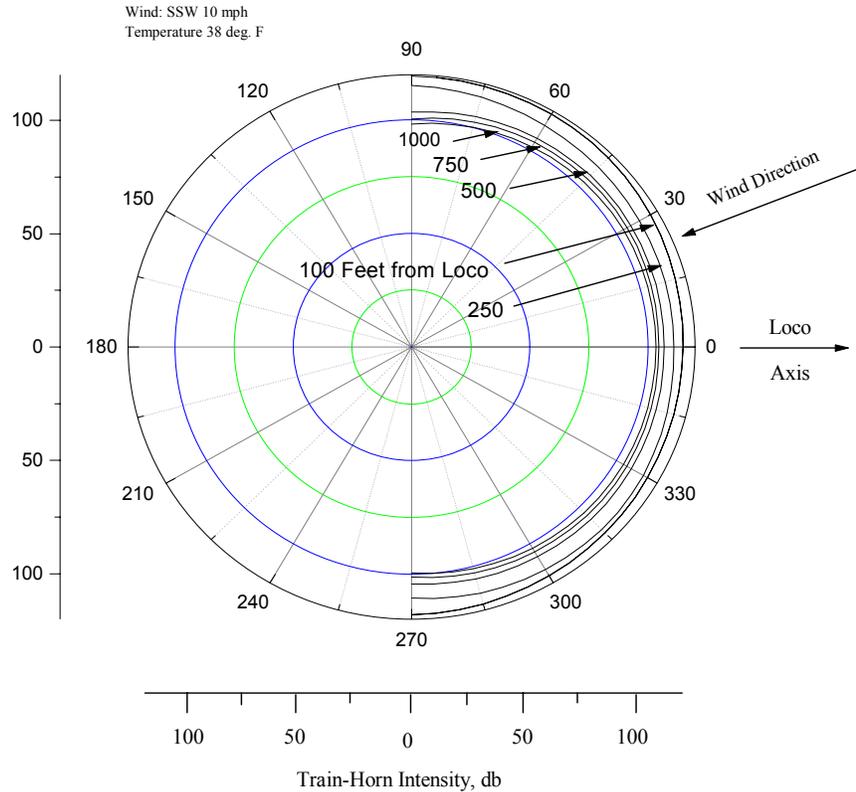
Figure 5-4. Measured Sound Intensity of Nathan P5 Horn*

⁶Since these tests are independent of a human's ability to hear, measurements are specified in dB and not dBA (A-weighted).

⁷The smooth curve between these measured points is generated by the cubic-spline method, which is a classical method for putting a smooth curve through known data points. It uses a third order polynomial to interpolate between each pair of data points.

Nathan P5 Horn	
Horn #	Frequency Hz
1	227.18
2	329.60
3	391.90
4	440.00
5	554.30

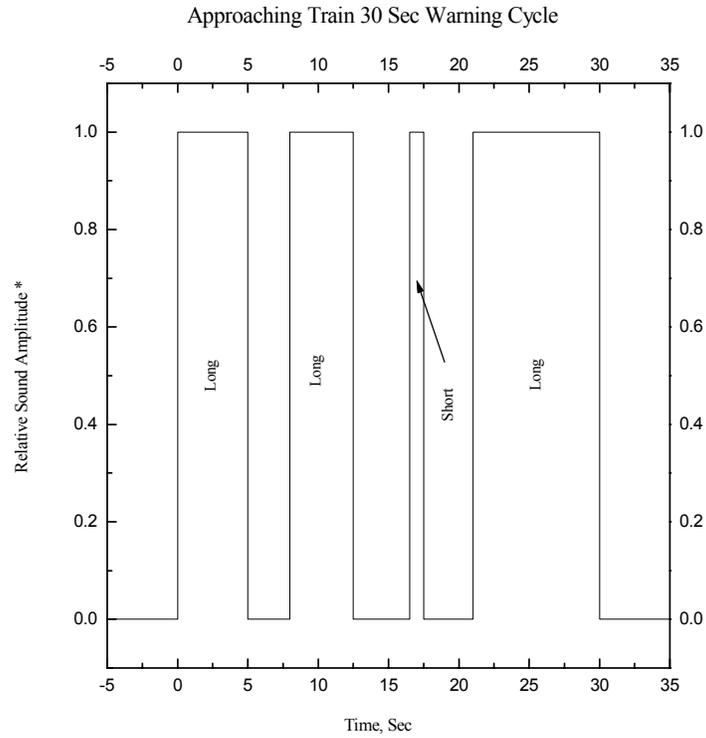
Figure 5-5. Single Horn Test Plot

* Vertical axis amplitude 1.0 = max db sound amplitude.

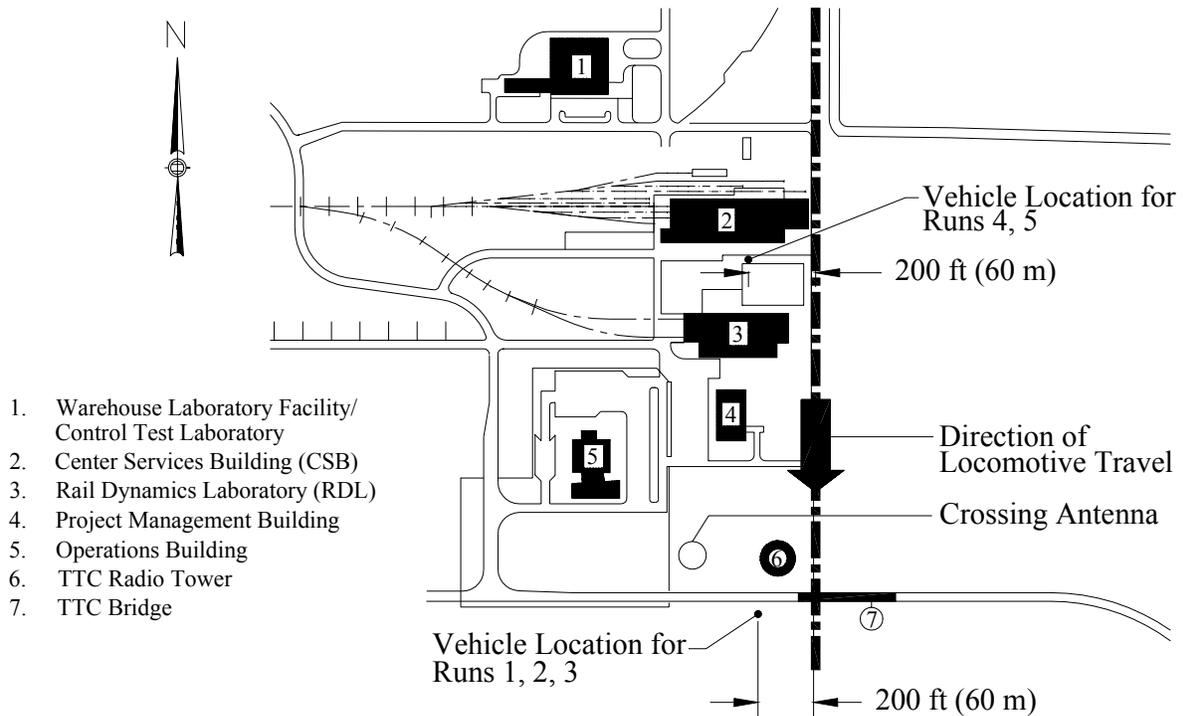
Figure 5-6. EARS Testing in Zone E

Structural Interference. During the five runs in Zone E, the vehicle was stationary 200 ft. (60 m), at two different locations, west of the test track while the locomotive traveled north to south at 30 or 50 mph (48 or 80 km/h); see Figure 5-6. Each run began approximately 1.25 mi. (2 km) before the vehicle and continued approximately 0.75 mi. (1.2 km) past the vehicle. The combinations of train speed and vehicle location for each run and the results appear in Table 5-14. The detection distances during these runs were shorter than those during the Phase 3 mobile-

locomotive tests in Zone B (see Table 5-10). These data indicate that the buildings and other structures significantly reduced the EARS reception range. However, the reception range is also influenced by wind direction and the direction that the microphone was facing.

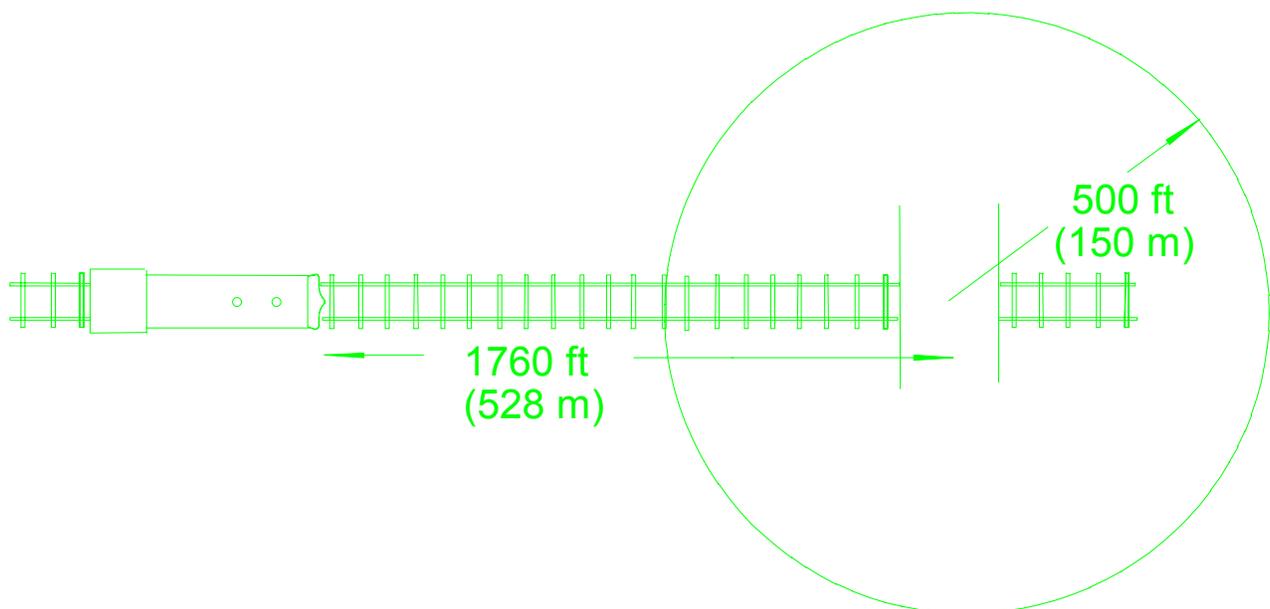
Figure 6-1. Minimum Range Required for the SmartStops System

Coverage refers to the area around the transmitter in which the signal can be received. Ideally, range and coverage should be measured for each system under the following environmental conditions:

However, it was not possible to collect those data for each system under all conditions. Thus, the data used for the range and coverage criteria was the maximum range of each VPAS component's signal recorded during any of the tests.

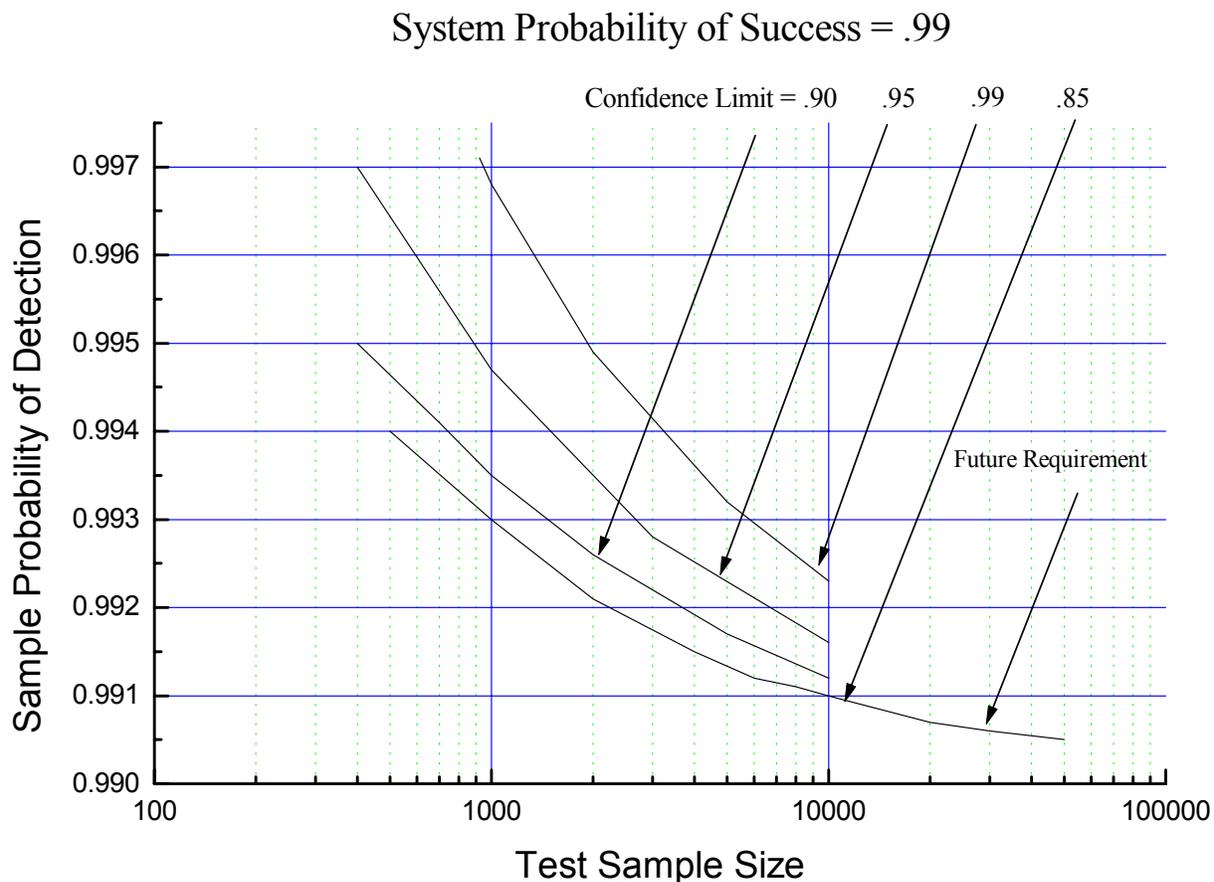
Figure 7-1. Detection Probability Confidence Limit Curve

The sample size needed depends on the desired probability of a successful warning and the desired level of confidence for achieving that probability. Using these two values, curves can be developed that will provide guidelines for sample size and for evaluation of the results. The following values seem to be appropriate for field operational testing (see Figure 7-1):

- Probability of success of the VPAS system = 0.99
- Confidence Limit for Probability of Success of 0.99 = 0.95

Based on these assumptions, at least 2,000 samples should be collected at each crossing. Data should be analyzed as testing proceeds to determine whether 2,000 samples are sufficient. If the rate of successful detections is below the confidence limit curve, additional testing may provide more insight into the system performance. The alternative would be to lower the performance requirements (i.e., accept a lower probability of success and/or lower confidence limit).
